Site-based practical conservation combining science and practical experience: Chippenham Fen

Based around a field visit 5th June 2023

This document summarises the topics discussed during a visit to Chippenham Fen, hosted by reserve managers Chris Hainsworth and Mike Taylor (Natural England). The site at Chippenham is described along with proposed management actions, with inputs and suggestions from other attendees highlighted with an asterisk (*). Evidence from literary sources is provided in green boxes.

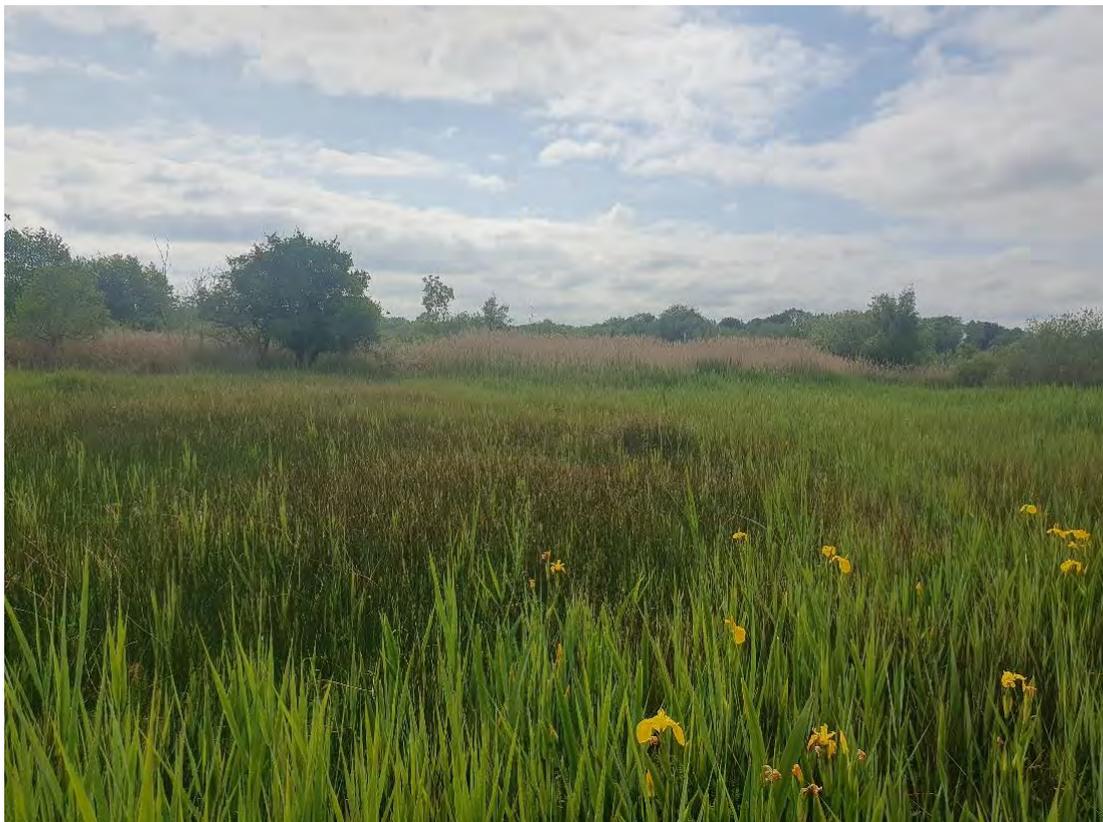
Pictured above is an area at Chippenham. The aim is to have more of the site looking like this.
